Command and Data Handling System (C&DH)

Comm Data Flow

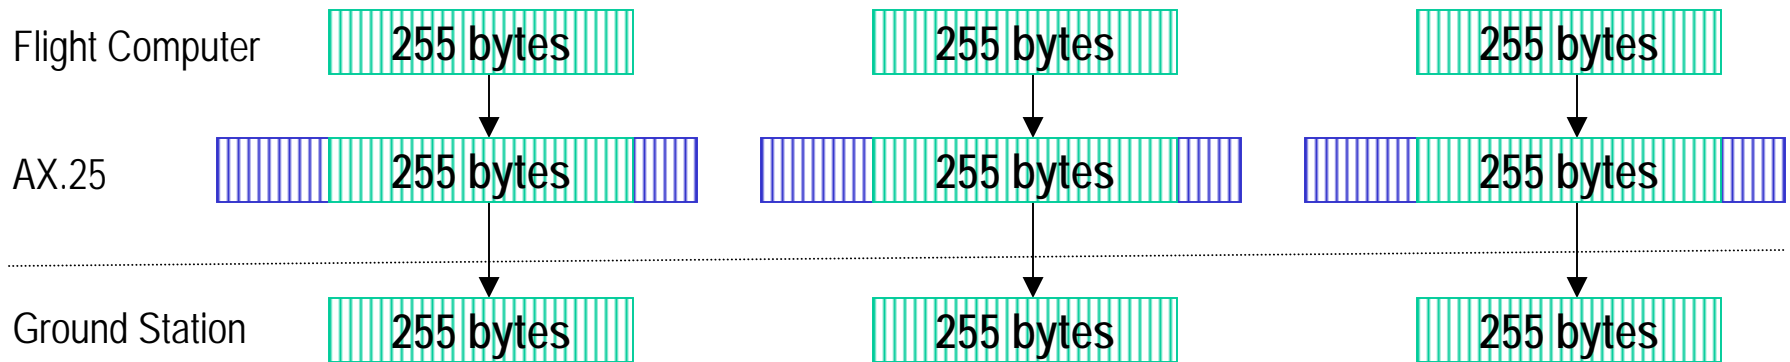
Synchronized Transmission (PPP packet size = AX.25 packet size)

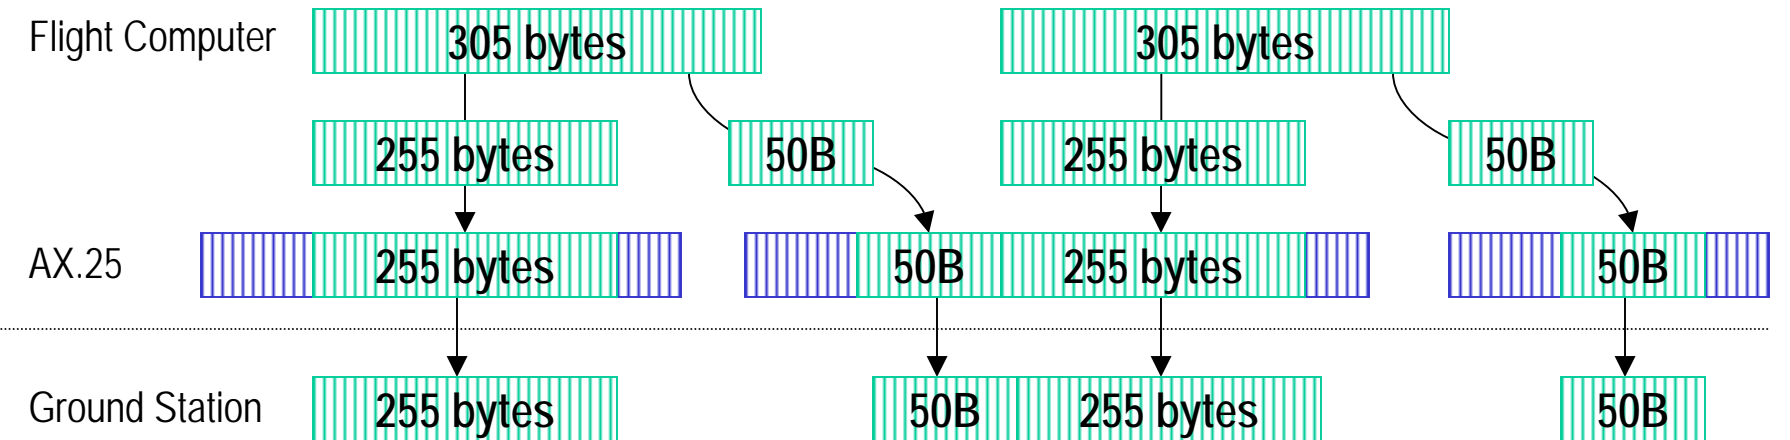
Unsynchronized Transmission (PPP packet size != AX.25 packet size) - a problem?

Original packet sizing shattered, but all bytes still arrive in the same order. Intrapacket timing issues?

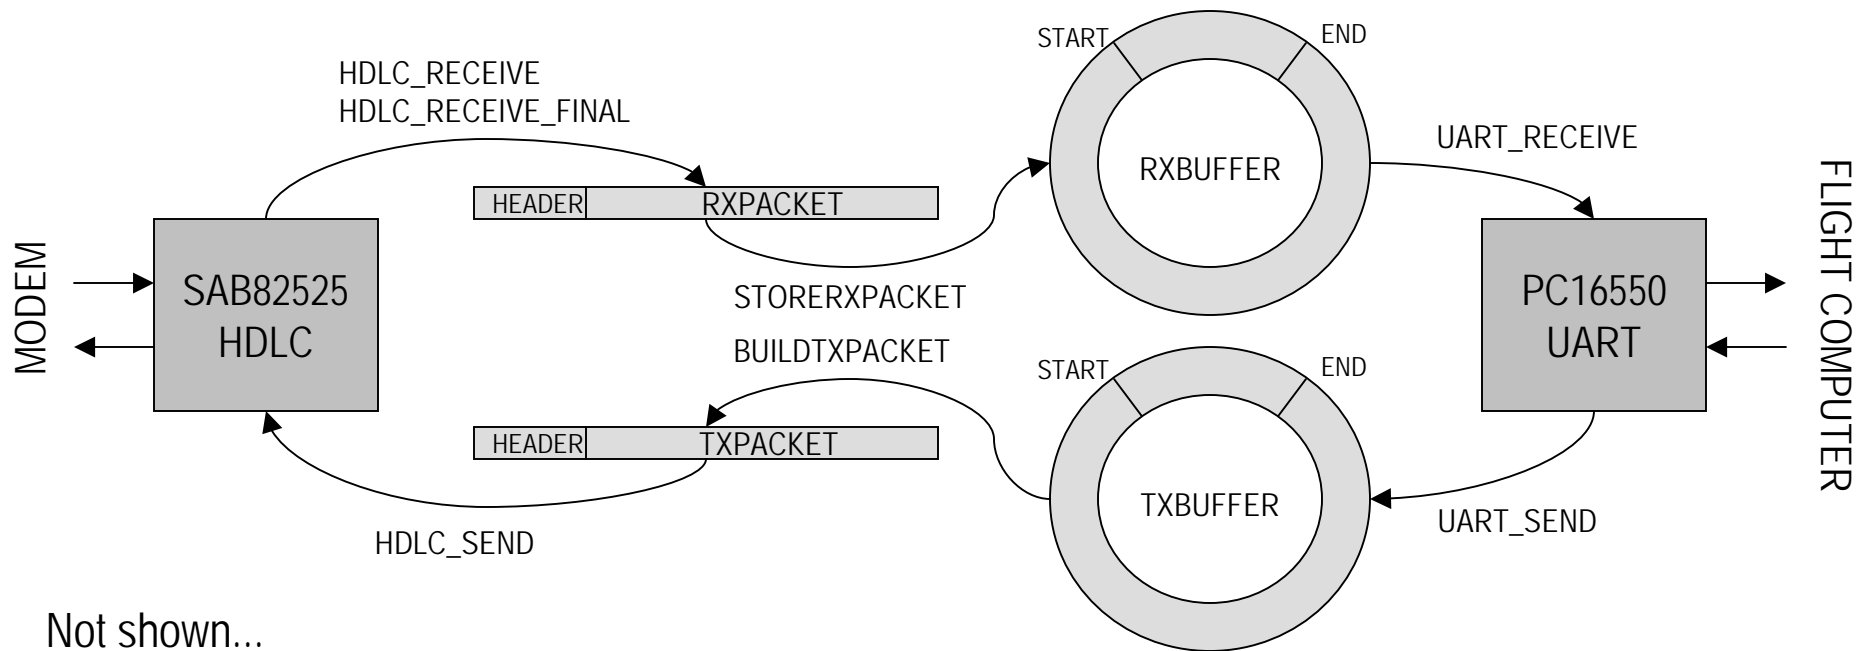
Not shown...

- ▶ AX.25 header build and check (100%)
- ▶ Timing to send short packets before data goes stale (90%)
- ▶ Refiring of Tx_buff_empty IRQs if data is not immediately available (80%)
- ▶ Edu-channel operation (75%)
- ▶ Error detection, handling, and recording for all buffers (50%)
- ▶ Transmitter auto powerup and timeout (50%)
- ▶ Parameter control of Modem and Transmitter (30%)
- ▶ Hardware handshaking with Flight Computer ("pause" functionality, 10%)
- ▶ Detection and shunting of Critical Commands to micronet and back (10%)
- ▶ Synchronization between Comm side and Micronet side (command waiting flags, etc., 10%)
- ▶ Micronet side reorg (transmit, etc., 10%)
- ▶ Micronet UART busy-wait issues? (reprogram UART for IRQ operation? 0%)

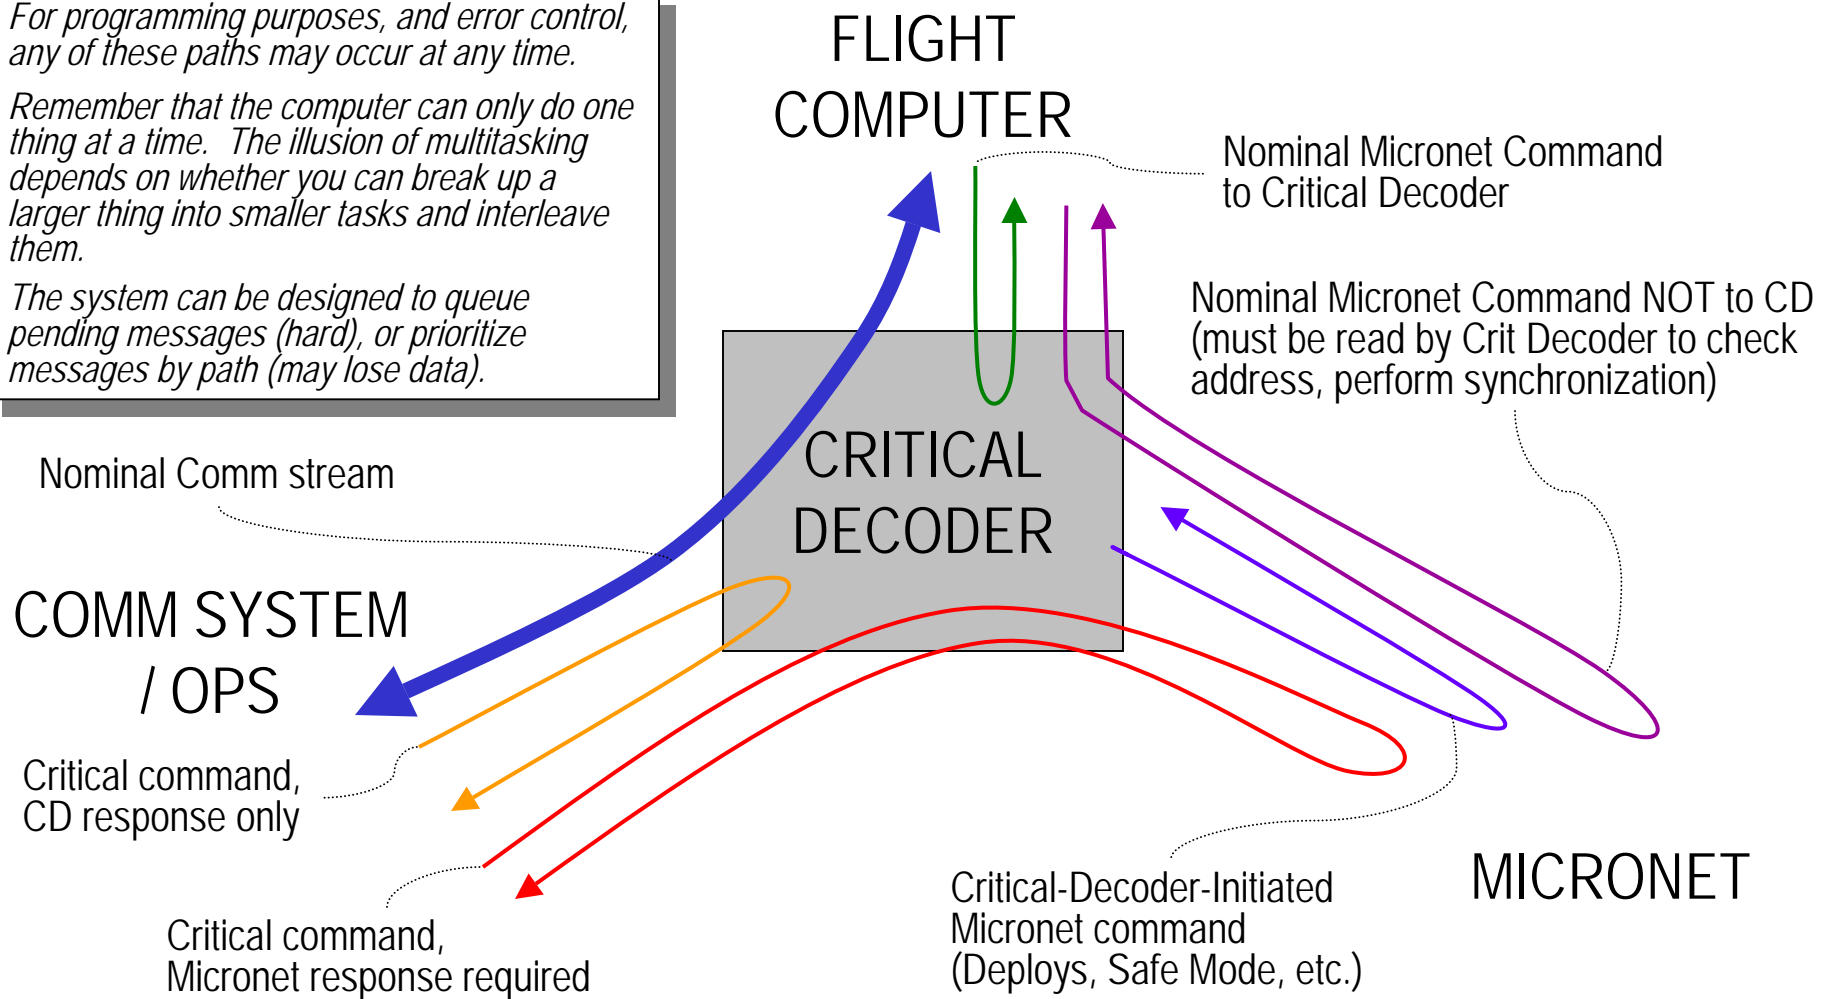
Possible Data Flows

Remember that the computer can only do one thing at a time. The illusion of multitasking depends on whether you can break up a larger thing into smaller tasks and interleave them.

The system can be designed to queue pending messages (hard), or prioritize messages by path (may lose data).
